E6211.02-113-11-R0
ACOUSTICAL PERFORMANCE TEST REPORT
ASTM E90

TREX COMPANY, LLC

Series/Model: Trex[®] Seclusion[®]

Type: Sound Barrier Fence

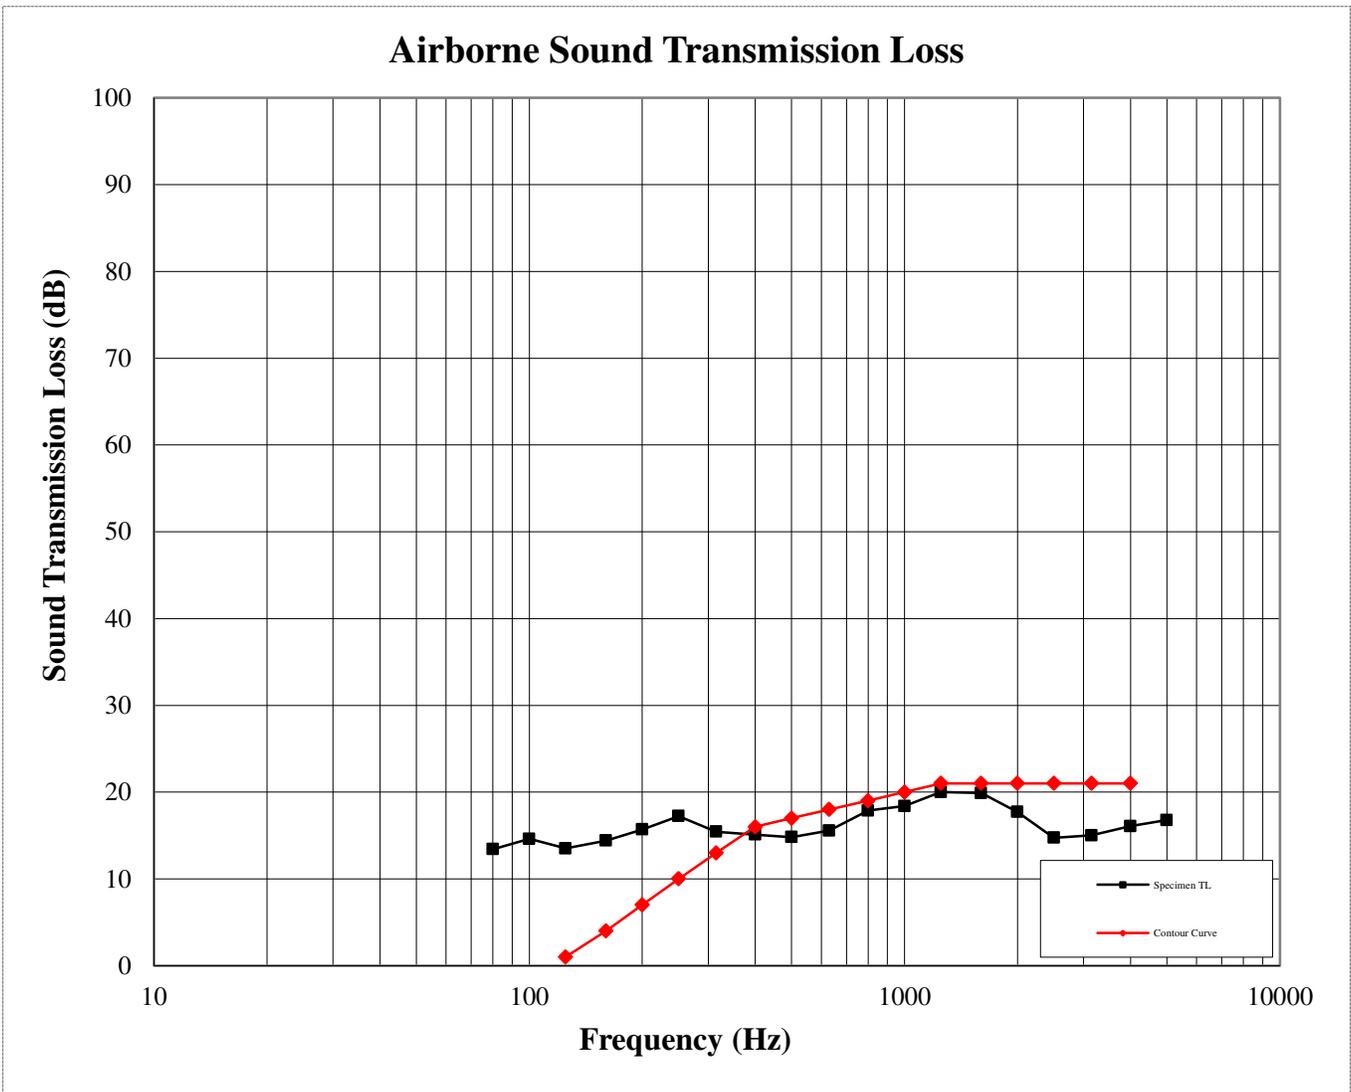
AIRBORNE SOUND TRANSMISSION LOSS
ASTM E 90

Test Date	03/24/15					
Data File No.	E6211.01					
Client	Trex Company, LLC					
Description	Series/Model: Trex® Seclusion®, sound barrier fence					
Specimen Area	5.95 m ²	Receive Temp.	22.5 °C	Source Temp.	20.9 °C	
Technician	Kurt A. Golden	Receive Humidity	46%	Source Humidity	47%

Freq (Hz)	Background SPL (dB)	Absorption (m ²)	Source SPL (dB)	Receive SPL (dB)	Specimen TL (dB)	95% Confidence Limit	Number of Deficiencies
80	38.3	4.4	105	93	13.4	1.86	-
100	35.7	3.9	105	92	14.6	1.55	-
125	37.7	4.9	105	92	13.5	1.48	0
160	43.1	4.6	106	92	14.4	0.75	0
200	39.2	4.9	105	90	15.7	0.98	0
250	33.2	5.0	106	89	17.2	0.64	0
315	27.7	6.1	100	85	15.4	0.38	0
400	28.1	6.3	100	84	15.1	0.33	1
500	25.8	6.3	100	85	14.8	0.31	2
630	22.1	5.9	101	86	15.6	0.35	2
800	18.9	6.0	100	82	17.9	0.15	1
1000	13.7	6.2	99	80	18.4	0.34	2
1250	12.1	7.0	97	76	20.0	0.29	1
1600	9.1	7.3	100	79	19.9	0.44	1
2000	5.3	7.8	99	80	17.7	0.20	3
2500	5.2	8.8	97	81	14.7	0.25	6
3150	4.7	10.5	98	80	15.0	0.17	6
4000	5.5	12.7	97	77	16.1	0.34	5
5000	6.2	16.3	94	73	16.8	0.20	-

STC Rating **17** *(Sound Transmission Class)*
Deficiencies **30** *(Sum of Deficiencies)*
OITC Rating **16** *(Outdoor-Indoor Transmission Class)*

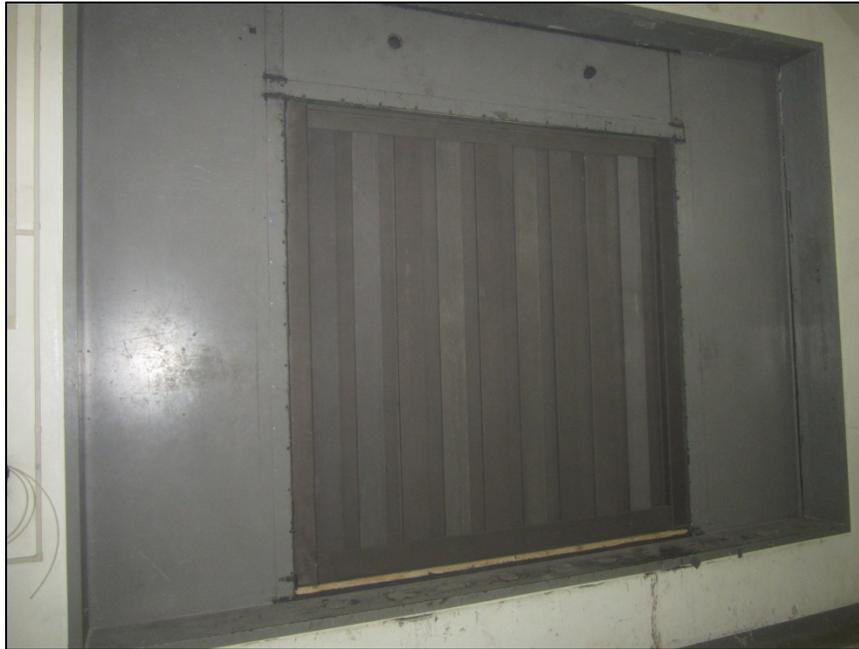
Receive Room View of Installed Specimen

A sound transmission loss test was initially performed on a filler wall. The 96" wide by 96" high specimen plug was removed from the filler wall assembly. The specimen was constructed in the laboratory per the manufacturer's instructions. Duct seal was used to seal the perimeter of the specimen to the test opening on both sides. The interior side of the specimen frame, when installed, was approximately 1/4" from being flush with the receive room side of the filler wall.

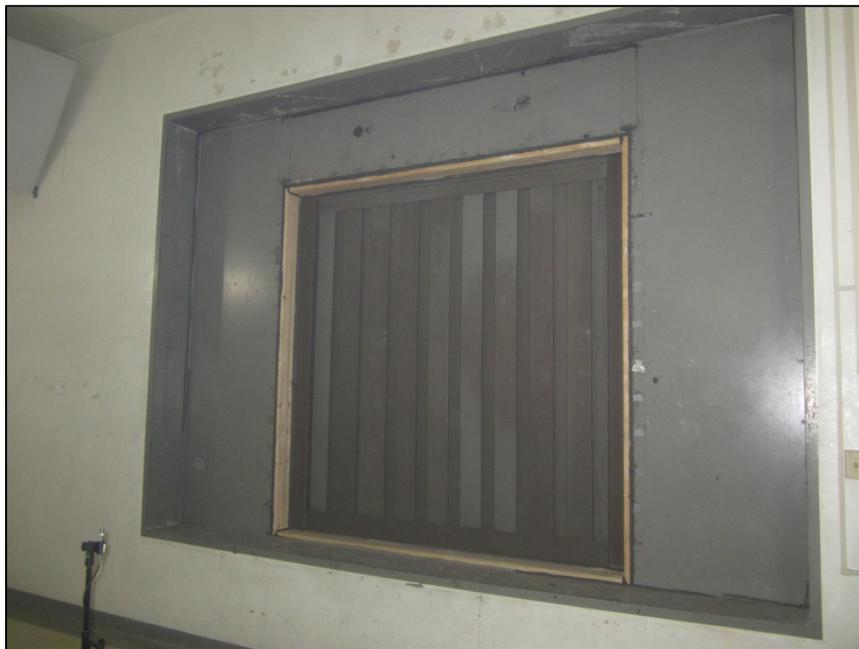
Source Room View of Installed Specimen
